COOPI

"Drought Consequences Alleviation in Borena Zone - Oromiya Regional State" Liben Wereda

Terminal report
April 2002-July 2003

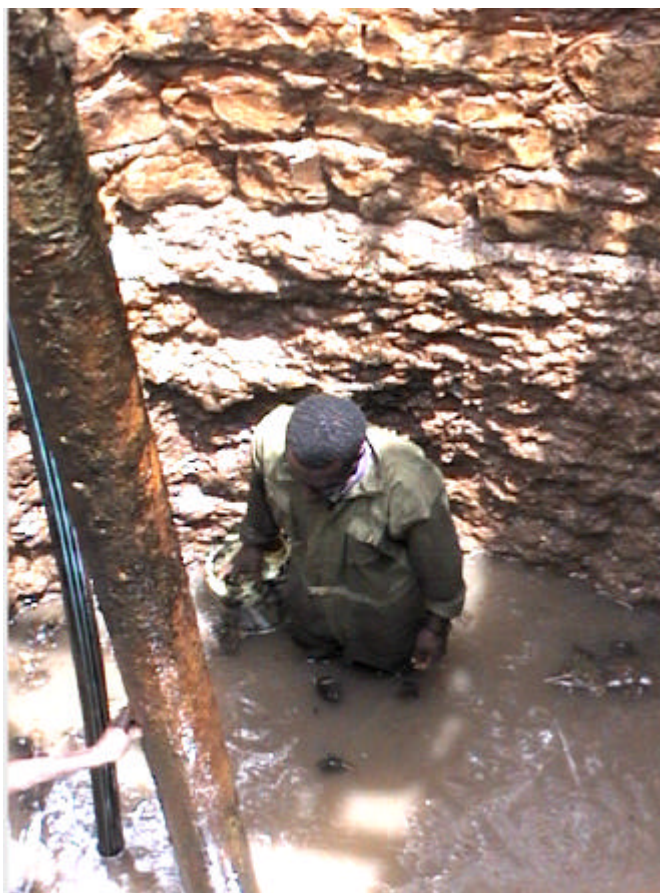
Figure 2: Dewatering of the wells of Negele Water scheme

Many dewatering attempts were made during the second quarter of the project, but the big quantity of water available in the wells together with some technical problems (like the uninterrupted use of the dewatering pumps that decreases their power) caused a slow down of the activity. Despite the use of four motor pumps at the same time only after 7-8 hours of dewatering the workers were able to enter in the wells and clean them, but after stopping the pumping the level of the water increased rapidly making the efforts very difficult. A trial with the rotation of six motor pumps that worked together with two submersible pumps was made. After 12 hours of dewatering it was impossible to decrease the water level and cleaning was not done.

Only at the end of September 2002 when the water department gave to us a high capacity pump to us it was possible to clean other two linear meters but without reaching the bottom of the wells yet. The situation of the wells was showed to the departments in Negele town whom only fear was to loose even the smallest amount of water out of the wells refusing the abandoning of two of the five wells. This was based on debatable suggestions because, as above explained, the amount of water withdrawn from the wells was so high not to justify their explanations.

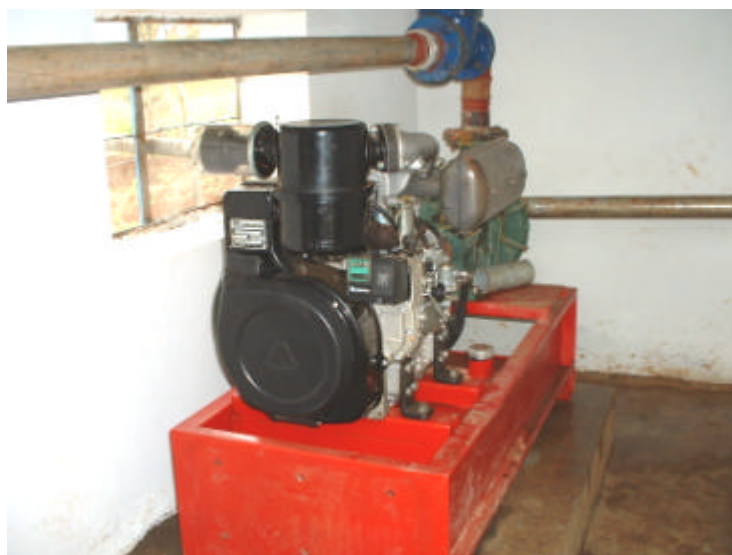
Figure 4: Booster pump after the rehabilitation

The re-construction of the booster pump's shelter started with the old pump removal and handing it over to the Water Department. Problems were related to the accessibility to the site that is into the compound of the Ethiopian Red Cross. The missing presence of the responsible of the Red Cross created disagreement with the guard that did not permit to the workers to enter and deposit materials in the work area. Only at the end of August 2002, it was possible to solve these problems but with a considerable delay in the activities.

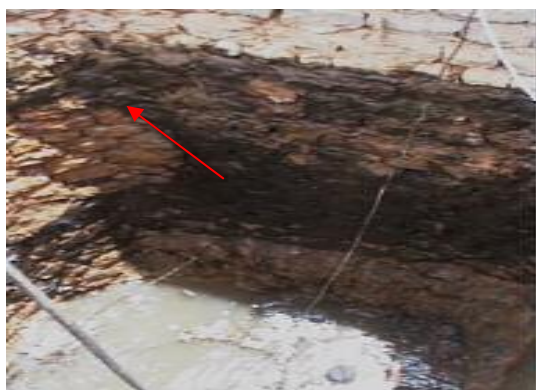
Objective #2 Increased safe water for drought affected rural communities

Rehabilitation of the wells by lowering concrete rings in to all the five wells was the first idea, but the idea dropout, because it could reduce the productivity of the well as result of artificially induced well-lose. The second idea was to maintain the retention wall of the wells and leave the wells as open wells (with out casing). This idea accepted by the respective expertise from the Zonal office of Water Resource and the rehabilitation work proceeded accordingly. The reasons for this are:

Fig-4 Initial condition of the retaining wall

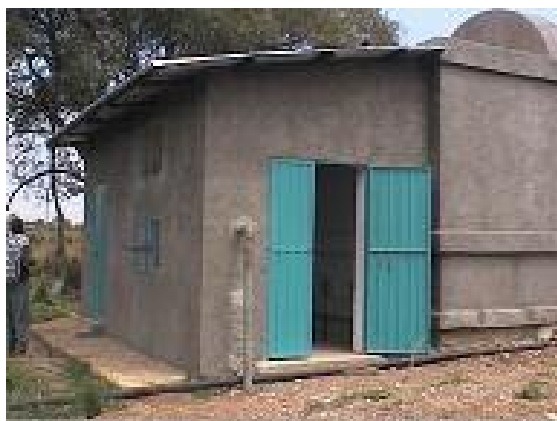
The former pumping house was build in attach with the back side of the reservoir. It was constructed by wooden wall and iron sheet roof. The house had two classes: the pump house and the store. It was almost completely destroyed; mean that not at the maintainable condition. Thus construction of new pumping house proposed in the place where the previous house lay on.

Fig-7 the new pump house constructed in attached with the reservoir

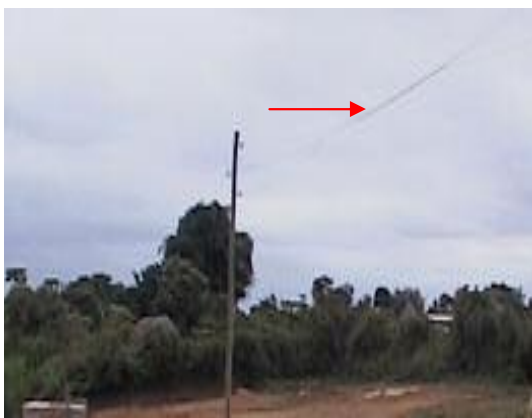
Submersible pump is a kind of pump preferred to pump the water from the wells to the reservoir. Mostly Submersible pumps use AC electric power driven, and previously the Water Service Office also had been using Submersible pump to pump water from the same well with power supply from the town power supply net work of ELPA. However, currently the power line which the water Service Office had been using is more or less destroyed, and it is in a condition that not possible to maintain.

Fig-13 Partial view of the previous power line.

Based on the suggestion from the respective expertise the line set under ground. PET electric cable of size 35mm/4mm used. The line prolong from the Water Service Office to the pump house, where the electric control switch board installed, through the compound of RED Cross Negele office. Then after the line go to the main well (well-three) where the Submersible pump installed. The over all length of the line along the route is 306m, and the line buried in the trench, which excavated priory, with depth of 1m below ground level. After all, the line connected with the existing power line switch of Water Service Office.
